SK686, COCKPIT VOICE RECORDER ANALYSIS

On Monday, October 8, 2001, a Scandinavian Airlines System MD87 collided with a Cessna Citation during take off from Linate airport, Milano, Italy. The aircraft's registration was SE-DMA and the flight number SK686. The Cessna was registered in Germany as D-IEVX.

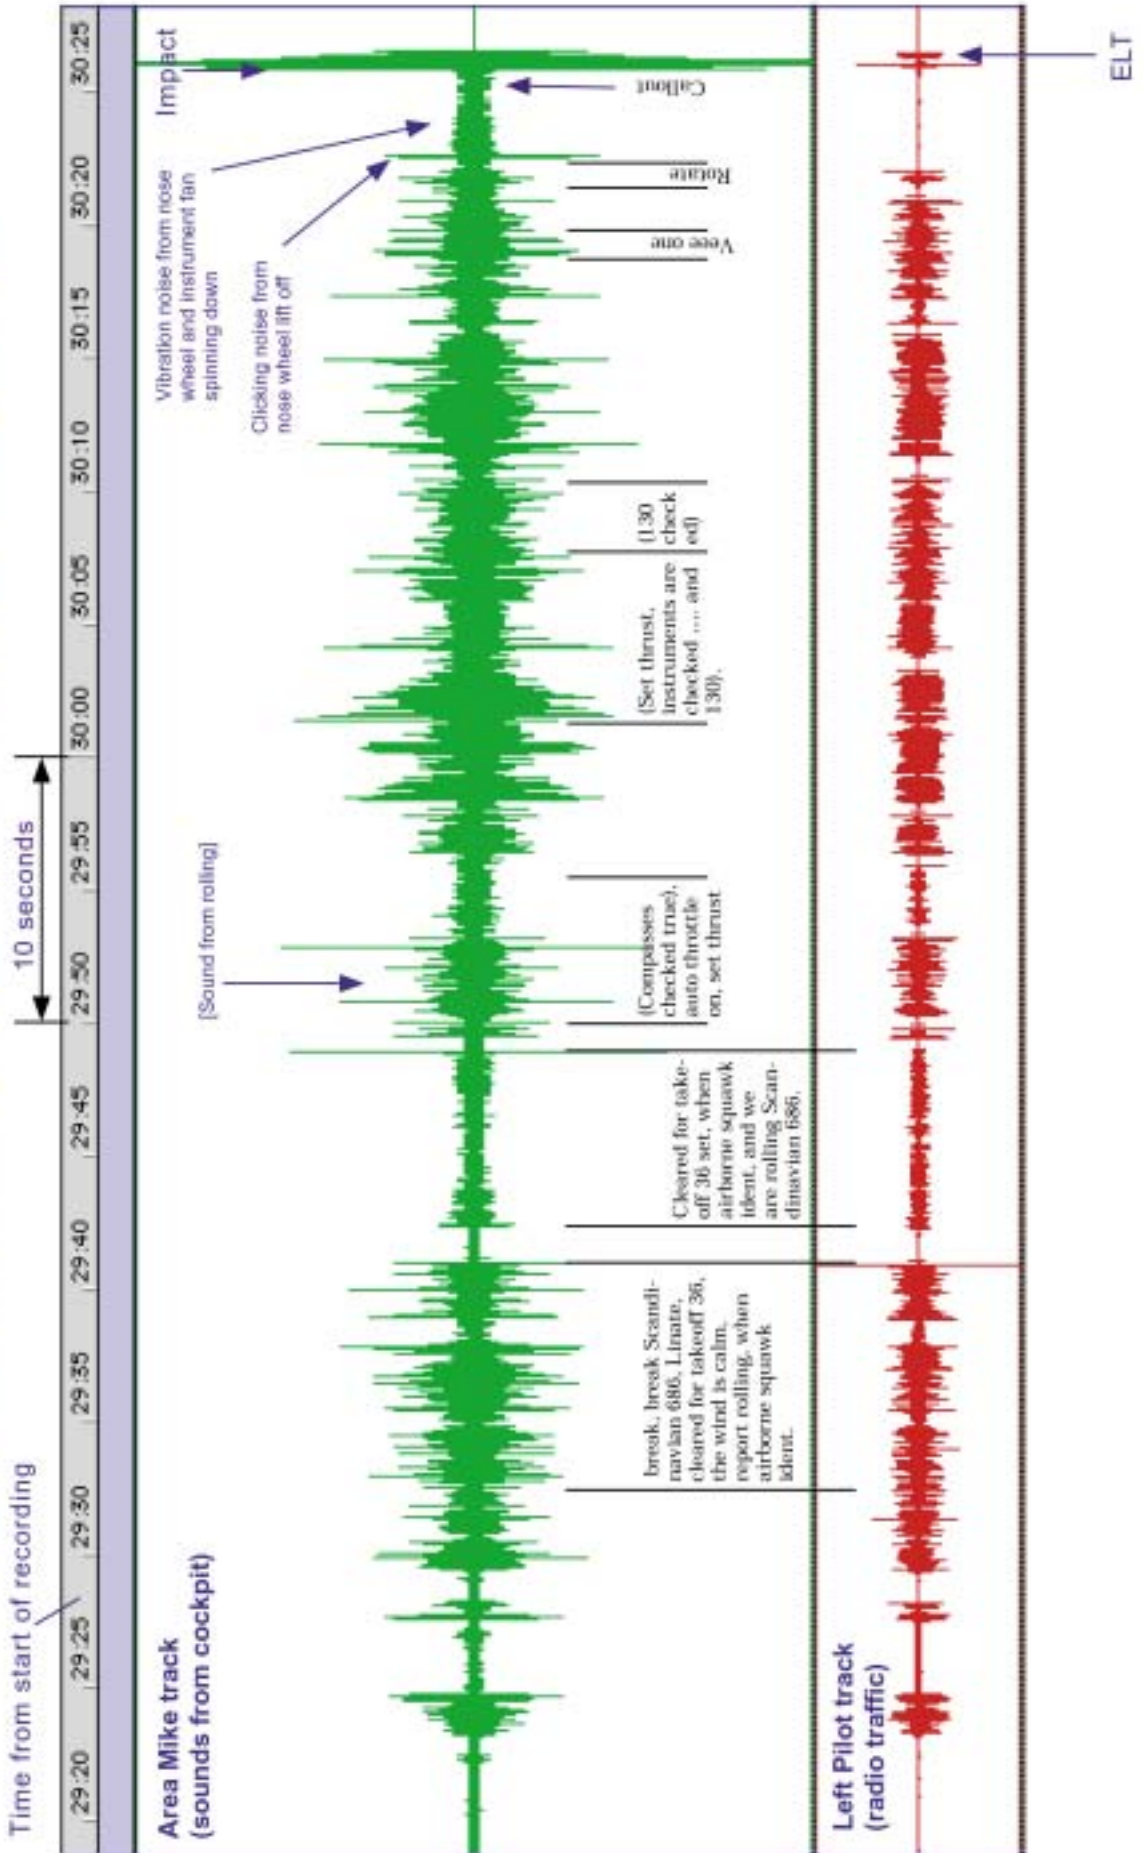
Appendix C

SK686 Audio Waveforms from last minute of CVR Area Mike recording

In the information it can be seen that SK 686 receives clearance for takeoff ca 06.09.24 UTC (29.29 minutes and seconds after CVR start) and that the collision occurs 57 seconds later (30:26 after start). From 7 until 5.7 seconds before impact the callout Vee one is heard, indicating that the aircraft has reached V_1 – decision speed. V_1 is normally the highest speed at which a take off should be aborted. As can be heard a few seconds earlier the V_1 speed is probably 130 knots although this callout is very difficult to hear due to interference from other radio traffic during the take off roll.

4.8 seconds before impact the callout "Rotate" is heard and ca 3 seconds before impact a clicking sound from nose wheel lift off. At impact the aircraft have accelerated for about 6 seconds above V_1 , which means the speed is several knots higher than V_1 .

The sequence of events from "cleared for takeoff" until collision has been plotted in **Appendix C**. In this appendix, as well as Appendix d-F, time is displayed horizontally and sound amplitude or frequency on the vertical scale.

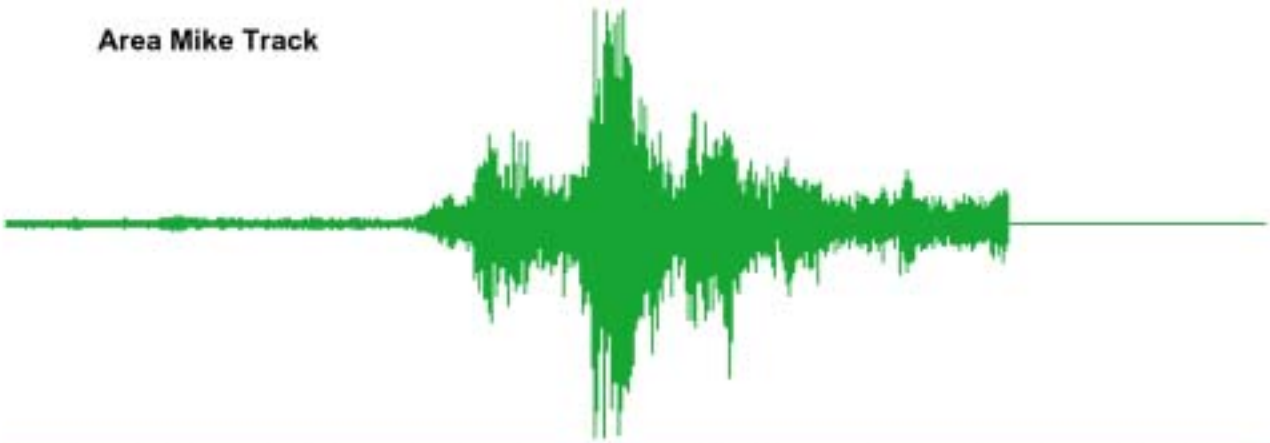
Appendix D

SK686, last second of CVR sound, all four tracks.

Area Mike Track

In **Appendix D** a graph of the last second of all four tracks have been made. On the vertical is sound amplitude and on the horizontal, time.

In this graph it can be seen on the AM track that the sound from impact starts ca 0.65 seconds before the recording (CVR recorder) stops.

The Left Pilot track is very similar to the Right Pilot track, which – as can be seen in the graph – is not perfectly synchronized with the other tracks. In the RP track, events are ca 0.1 second before the LP and SI tracks, which in turn are about 0.05 seconds before the AM track. According to BFU (Bundesstelle für Flugunfalluntersuchung) the time difference between the four channels is an effect of the copy process. Due to software limitations, the CVR content was played back and copied in an analogue format, then digitalized again into .wav files. It is of course easy to synchronize the tracks within milliseconds, using the last events on the tracks, and this was also made for the purpose of getting correct timing.

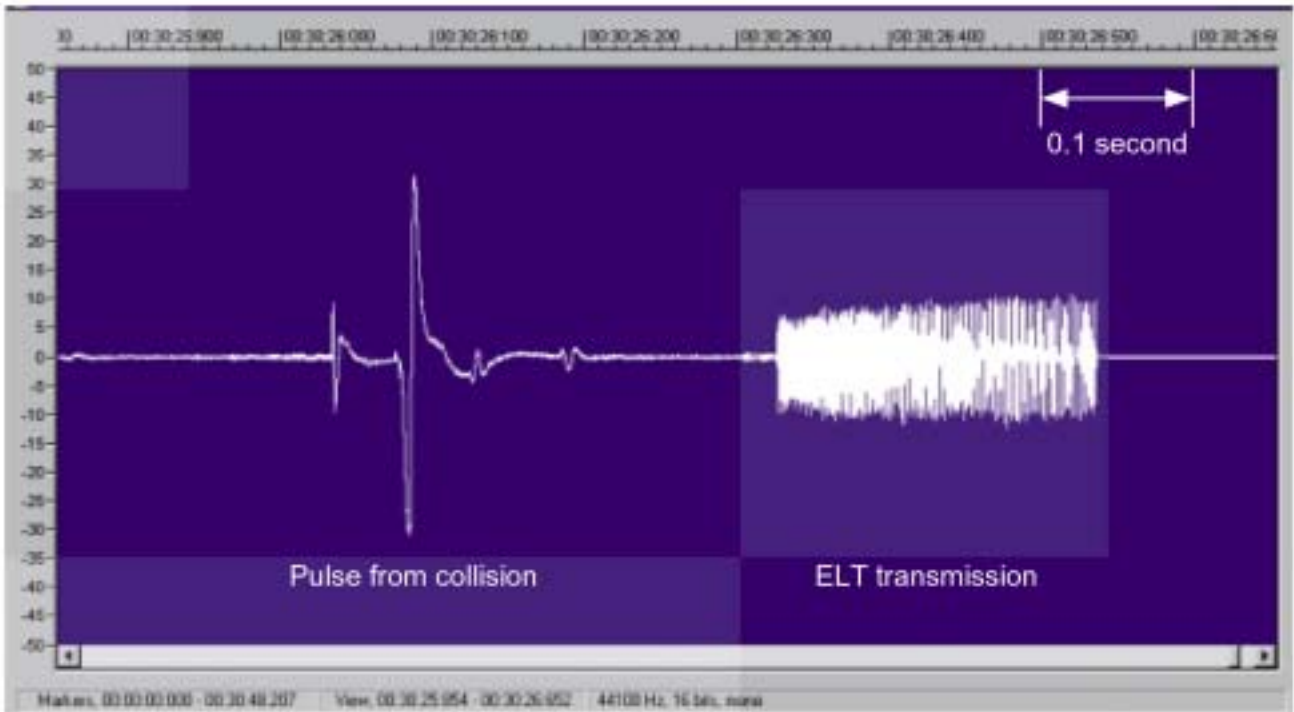
SK686, last second of CVR sound, Left Pilot track.

Above is the waveform from the last part of the CVR recording on the Left Pilot Track

Below is a sonogram from the LP track. The descending lines are from ELT transmission.

Appendix F shows a graph show ca 0.7 of the last second of the Left Pilot track.

In this graph there is a heavy spike (disruption) starting 0.50 seconds before end of recording and about 0.17 seconds long, most likely emanating from the collision.

At the very end of the recording there is 0.21 seconds of sound from an ELT (Emergency Locator Transmitter), starting its first sweep.

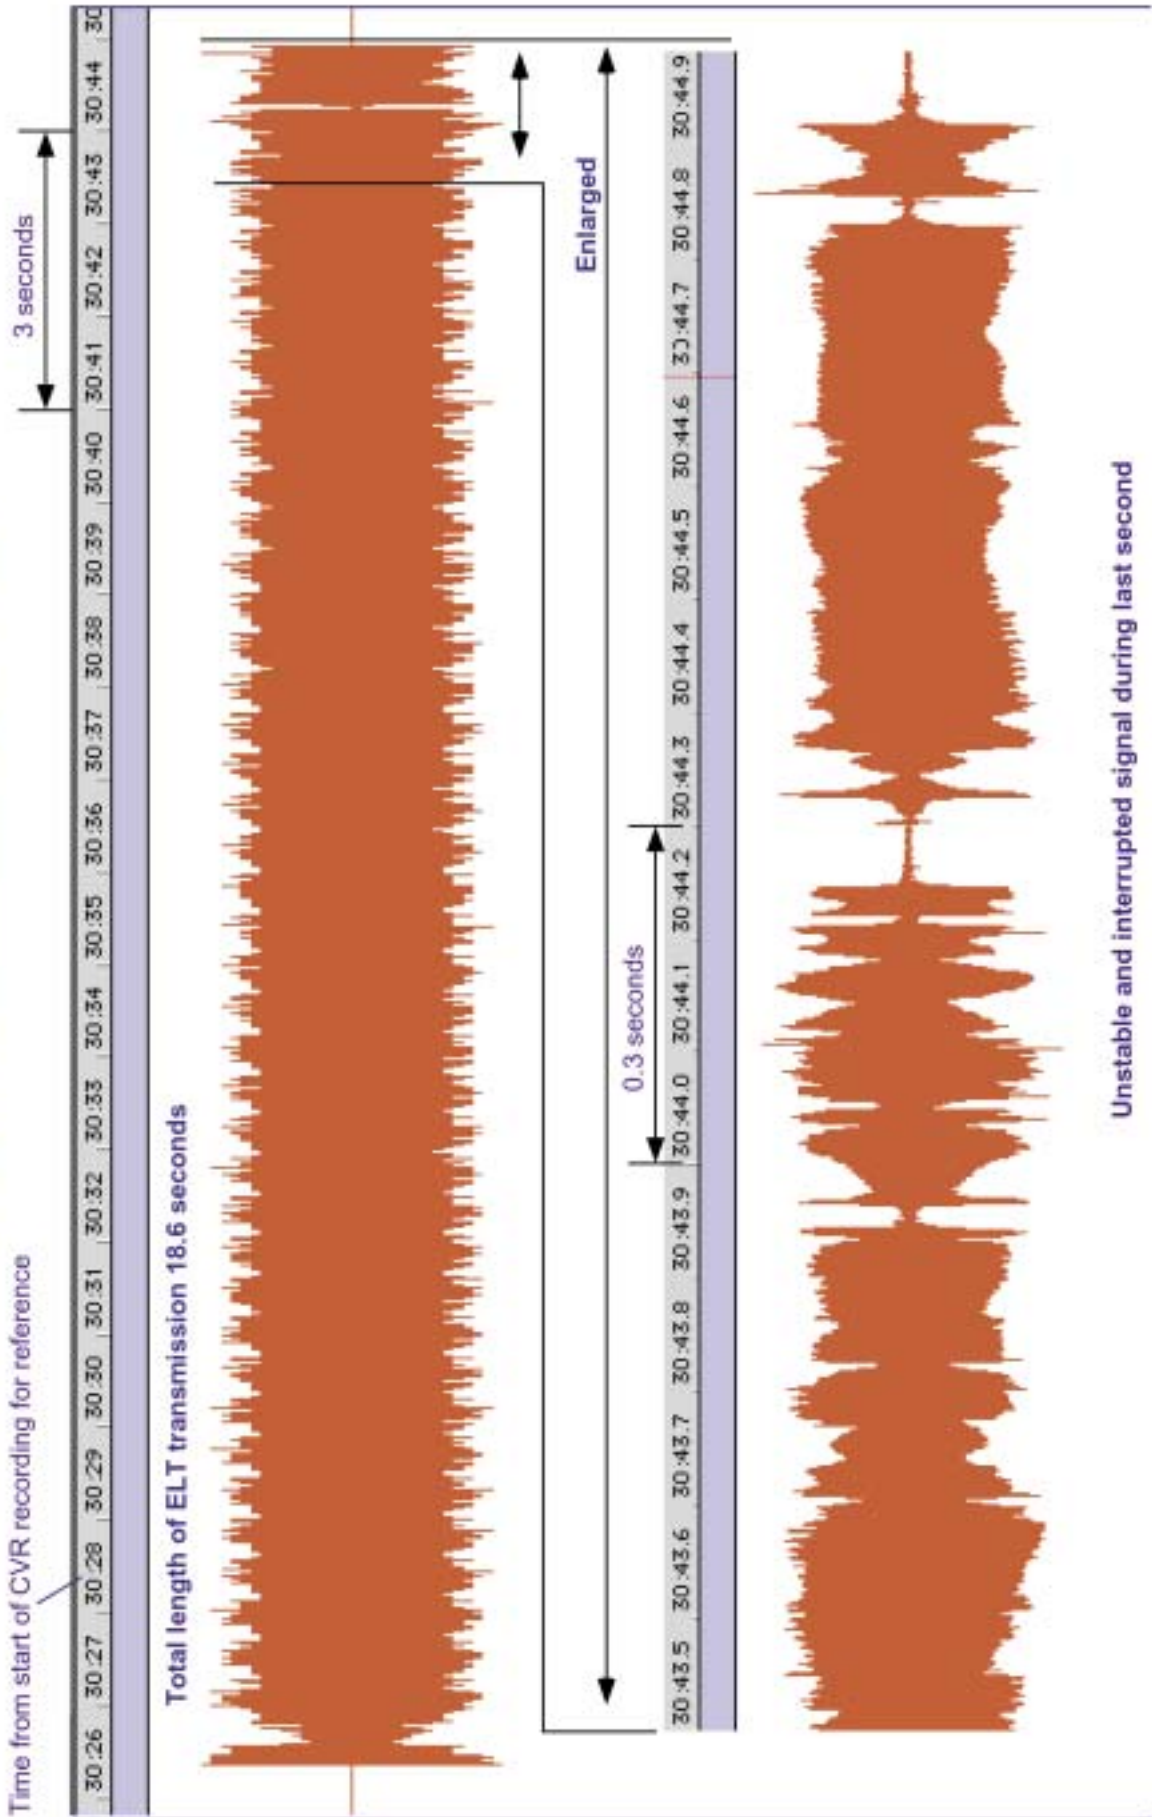
Appendix G

Audio Waveforms from ELT transmission on 121.5 MHz

On the Emergency frequency an ELT can be heard very clearly starting at the same time as on the CVR recording. The ELT can be heard for 18.6 seconds. The transmission is stable for the first 17.6 seconds, while during the last second, the signal is unstable and broken. – See appendix G.
